Manhole Inspection Summary

Manhole # S33OO_044MH

Insp Date: **4/24/07 12:34 PM**

Location Address: **16 LOVEGROVE ST**

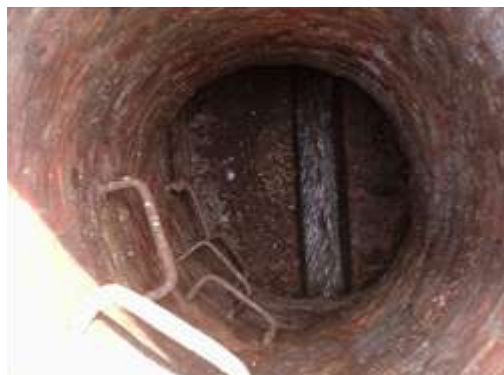
Top View

Corroded steps. Evidence of surcharge - Bench debris.

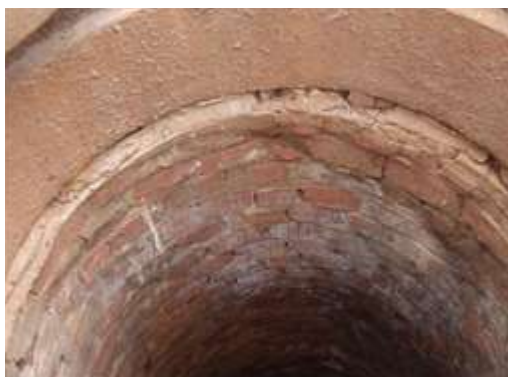
Defect

Frame leaks. Adjustment deterioration, root intrusion and infiltration. Barrel infiltration - other side.

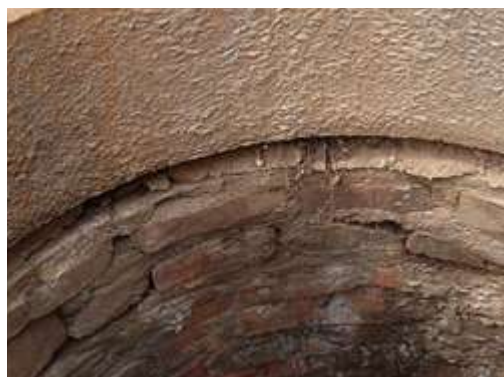
Defect

Frame leaks. Adjustment deterioration, root intrusion and infiltration.

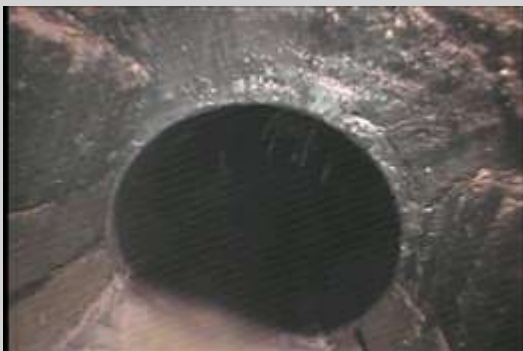
10 in. Circular Gravity Sewer Pipe In @ 6 O'Clock

Pipe Material: **Clay** ☐ Pipe Lined

Invert Depth: **11.24** (ft.) Flow Characteristics: **Slow**

Deposits: ☒ None ☐ Mud ☐ Sludge ☐ Debris ☐ Grease

Infiltration: **None** Pipe Seal Cond: **Unknown**
